May 18, 1987

Re: Our letter dated May 11, 1987.

As indicated in referenced letter, Ace Galvanizing has initiated corrective actions to the improvements suggested by the N.W. Regional, DOE Response Team. This letter constitutes our first progress report in correcting those deficiencies noted by the Response Team. Also, as indicated in referenced letter, our periodic, updated progress reports will contain photographs of the areas where improvement actions have been taken. This procedure will continue until the areas of concern have been improved to the satisfaction of the DOE EBAT Team, DOE Response Team and Seattle/King County Health Department.

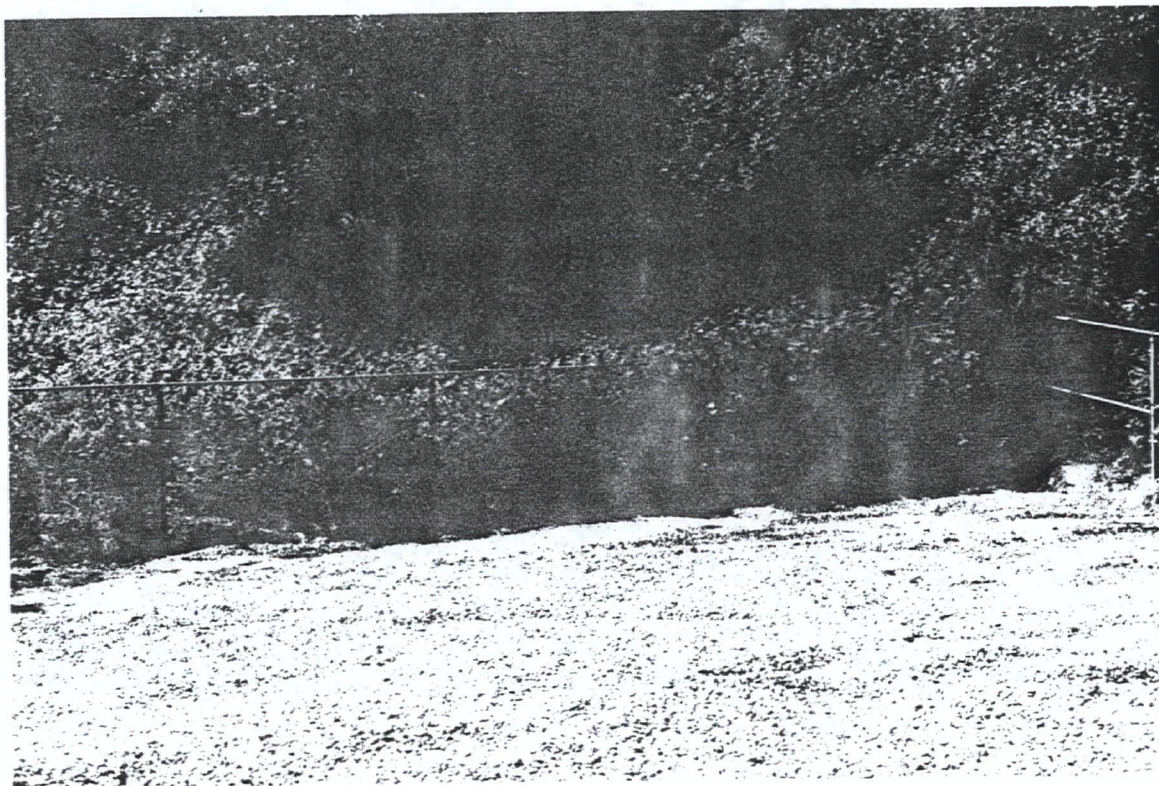
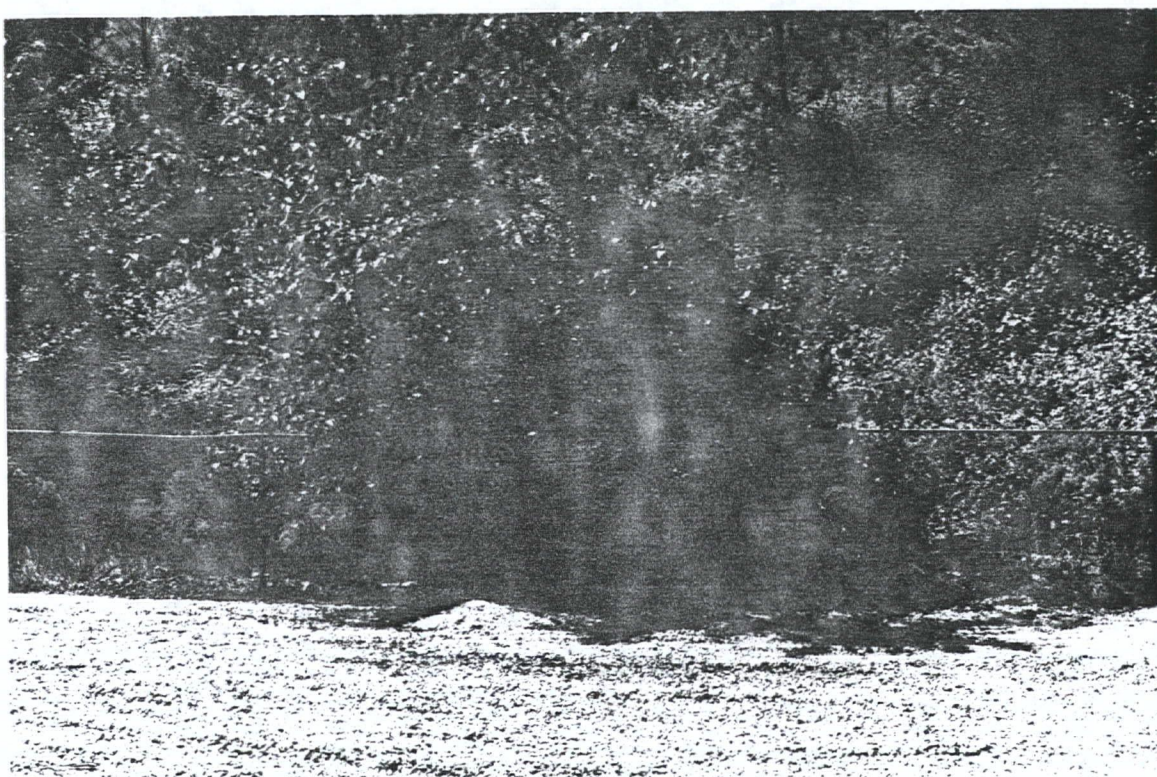
Status: All barrelled By-products have been separated by composition and color; barrels numbered, and all barrels have been moved to a sheltered warehouse area for protection from the elements pending disposal instructions to be received from Seattle/King County Health Department. Additionally, the outdoor area where the barrelled By-products were stored has been cleaned and the area gravelled over as indicated in the

photos, numbers 1 and 2, attached below.

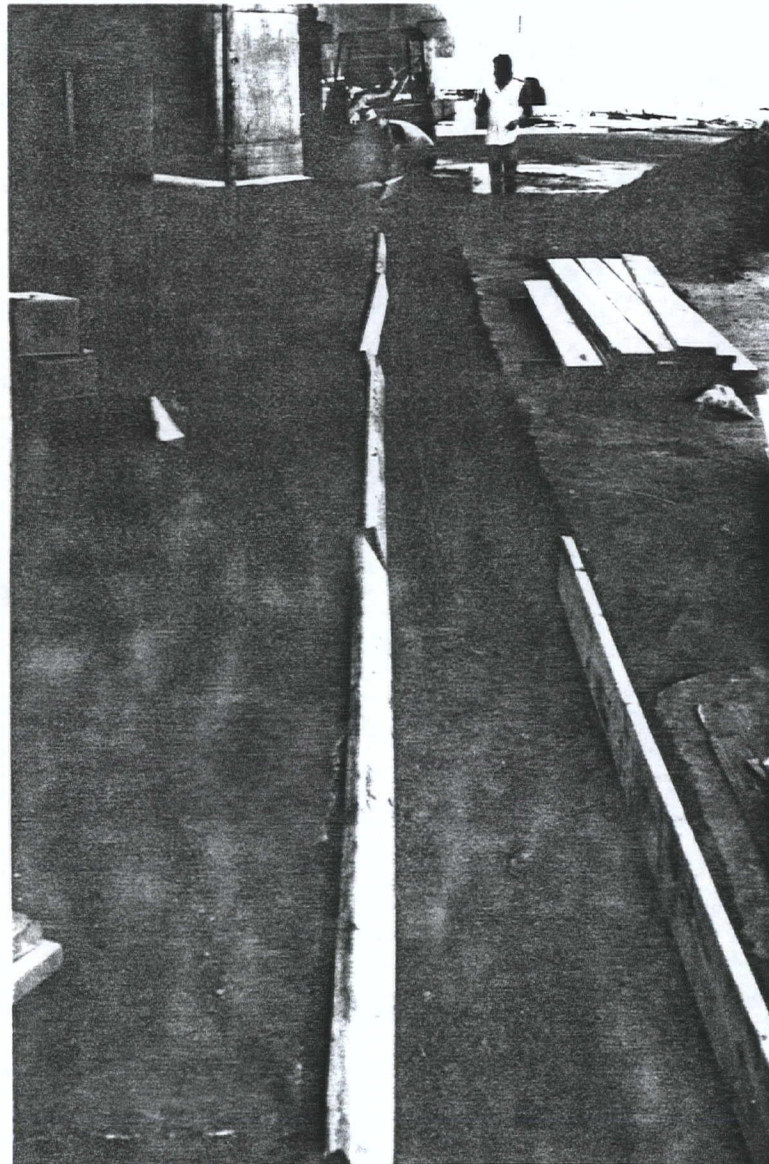
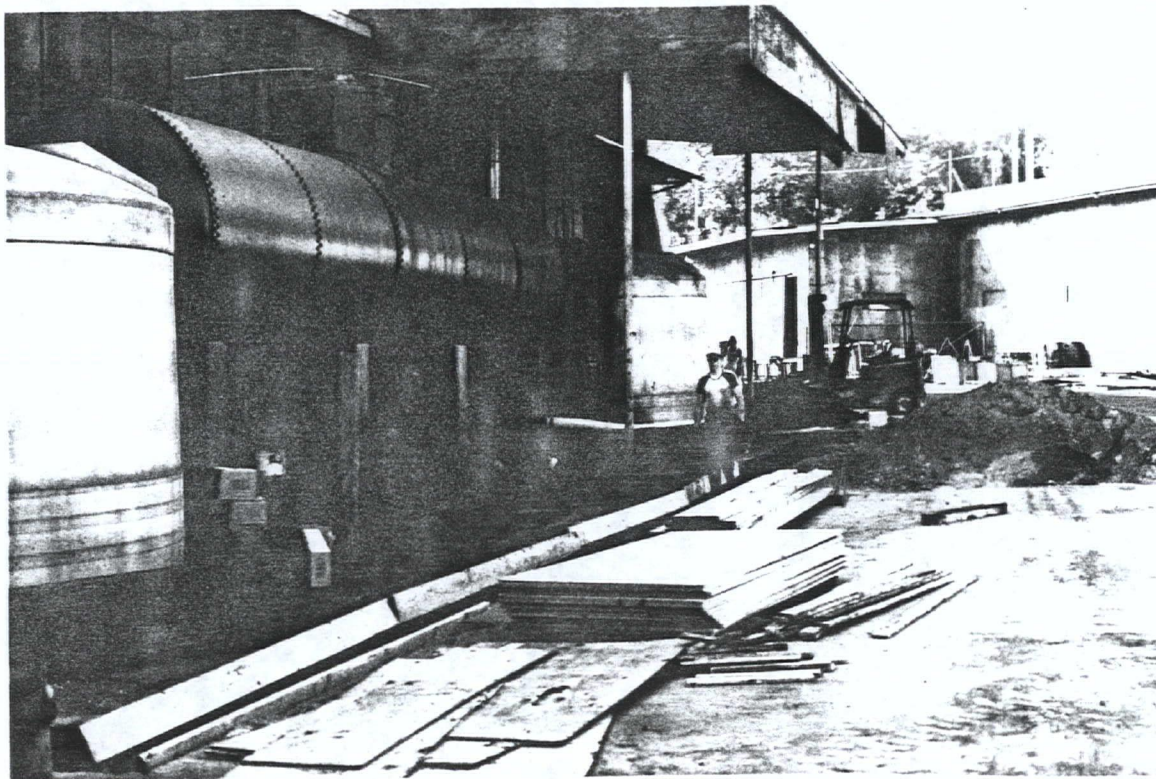
Status: Work has been initiated to re-route surface run-off away from the galvanizing building. A Concrete Berm will be constructed to direct the surface run-off flow to the storm drainage sump located at the southeastern end of the building. Additionally, a Retaining Wall is under construction that would contain any spillage from the storage tanks on the western side of the galvanizing building and also serve as a berm to direct surface run-off to the southeastern storm drainage sump (see photos number 3 and 4, below and on page five). This will be further described in our Drainage Plan to be submitted later to DOE.

Additionally, a Retaining Wall is under construction along the eastern side, and within the Galvanizing Building, where surface run-off with the high acidic PH Factor escaped into the storm drainage sump located at the southeastern corner of the Galvanizing Building. This Eastern Retaining Wall, located within the Galvanizing Building, will contain the process area as requested by the Response Team. Additionally, the employees have received instruction and training concerning the need to prevent surface run-off and, in general, the need for better "housekeeping". Also, the Company has directed the Environmental Consultant to write a Spill Prevention and Containment Contingency Plan. A copy of this plan will be provided to DOE when completed.

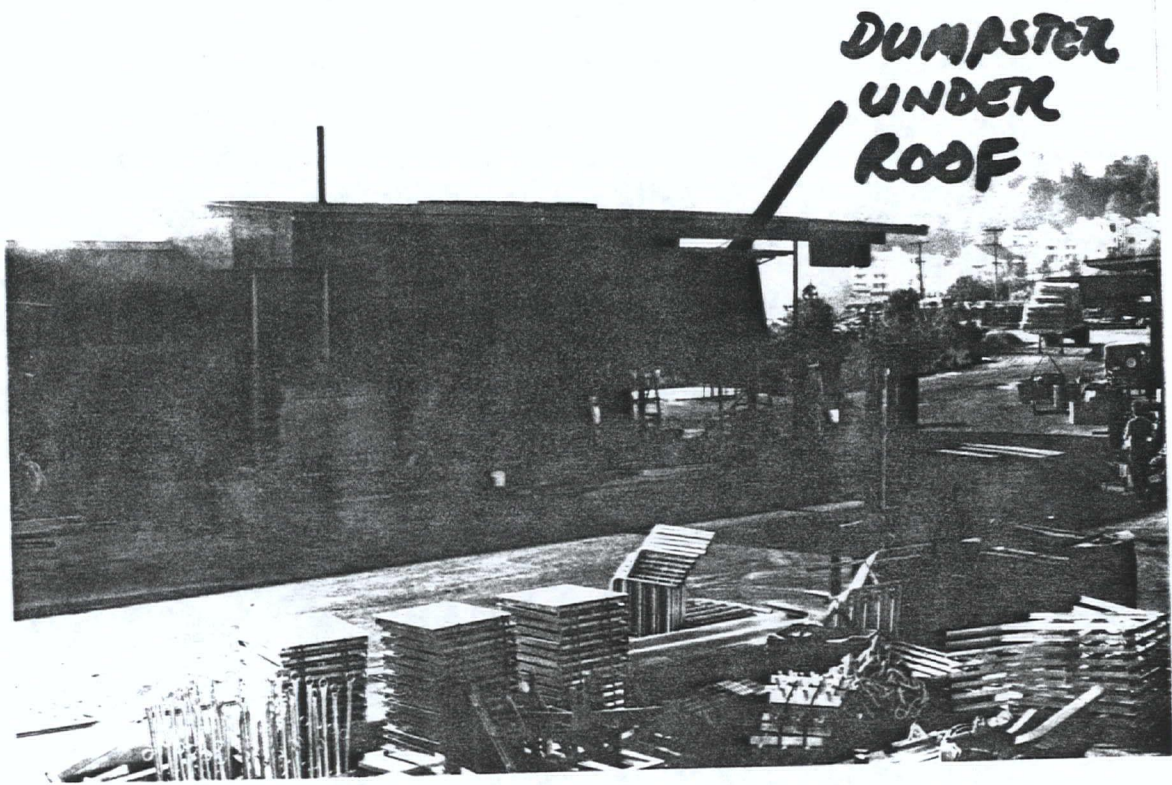
Requirement: Materials placed within the dumpster must be suitable for landfill disposal only. As is, the dumpster does not meet minimal functional standards in that there appears to be fluid running out the bottom, which contributes to the surface run-off problem. Need to place the dumpster in a "car-port" type structure where precipitation will not enter into the dumpster itself.

Status: Only wastes suitable for landfill disposal are placed in the dumpster. The dumpster will be placed under a permanent roof structure located on the western side of the Galvanizing Building, as indicated by the arrow on photo number 5 on page six. The dumpster will be in place as soon as the retainer wall and run-off berm have been completed.

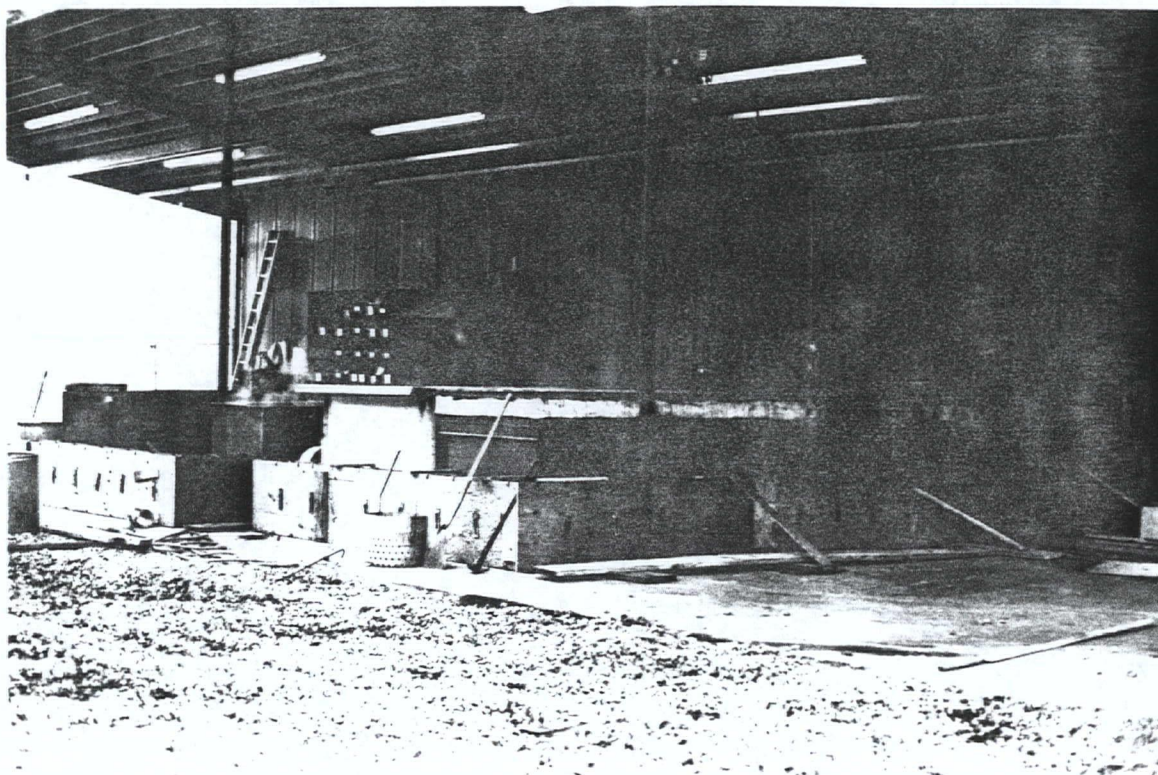
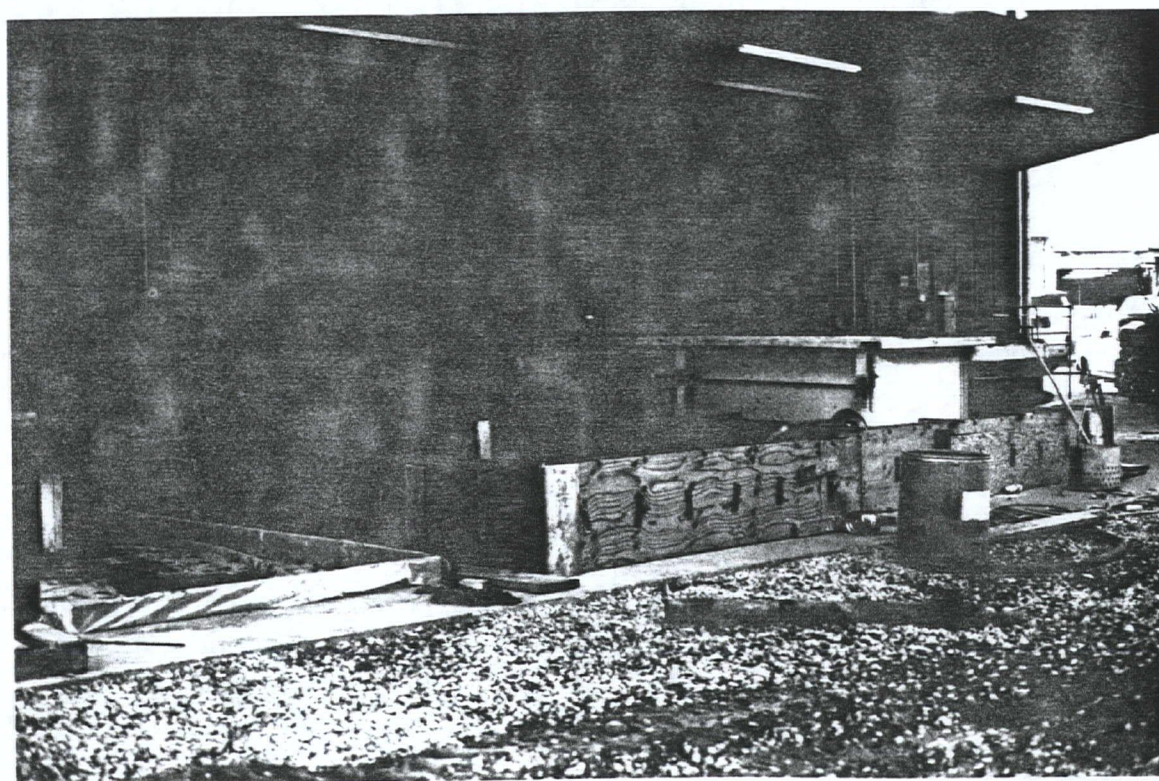
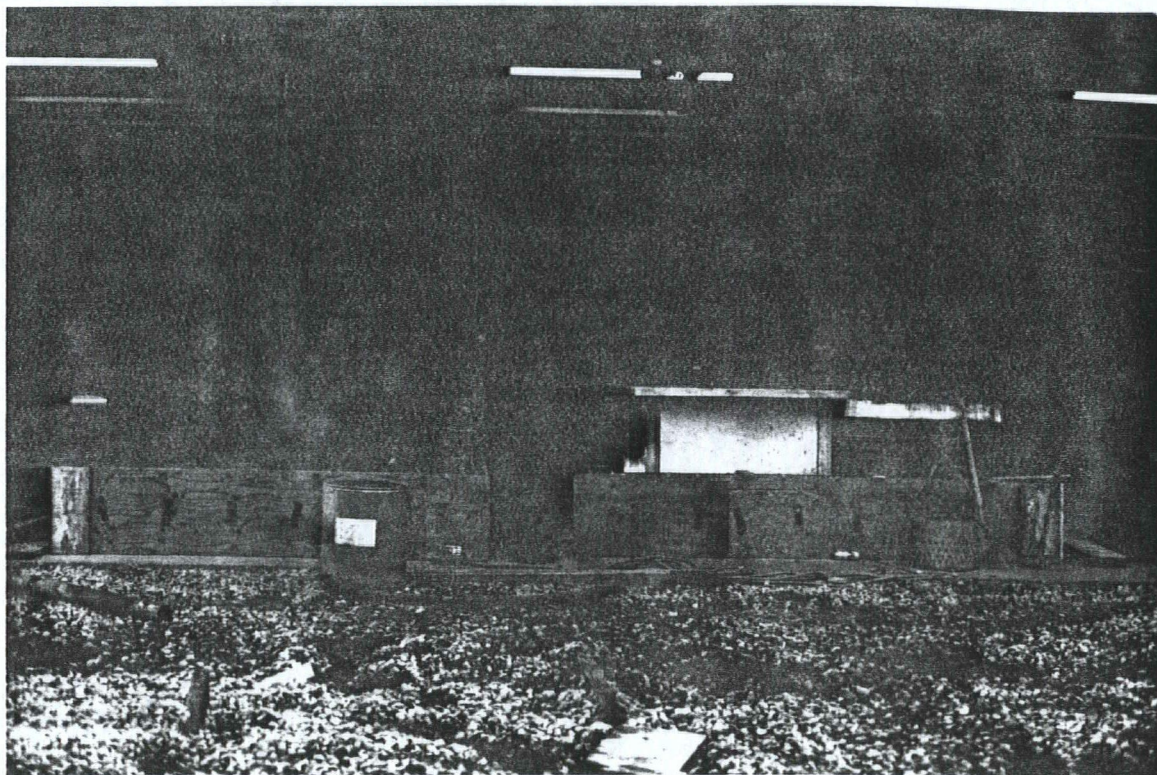
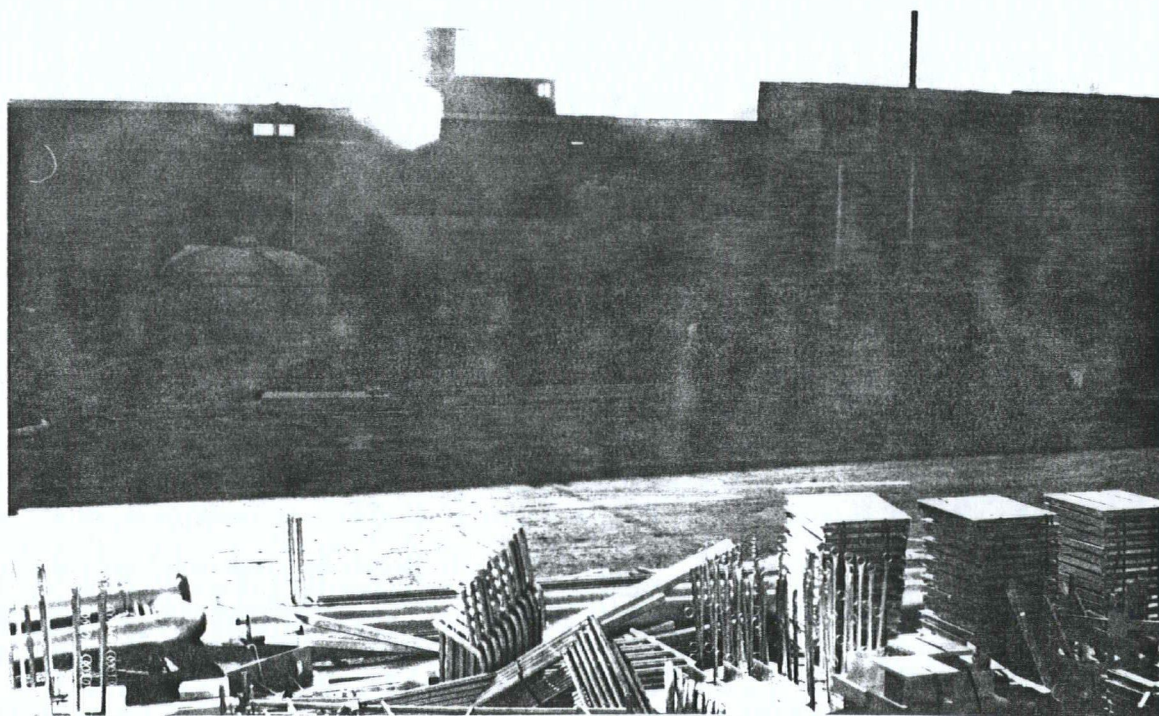
Status: Containment in the form of retaining walls and run-off berms are under construction throughout the facility. Employees have also been trained to improve "housekeeping" operations. Photos number 6 through 9 demonstrate on going containment construction.

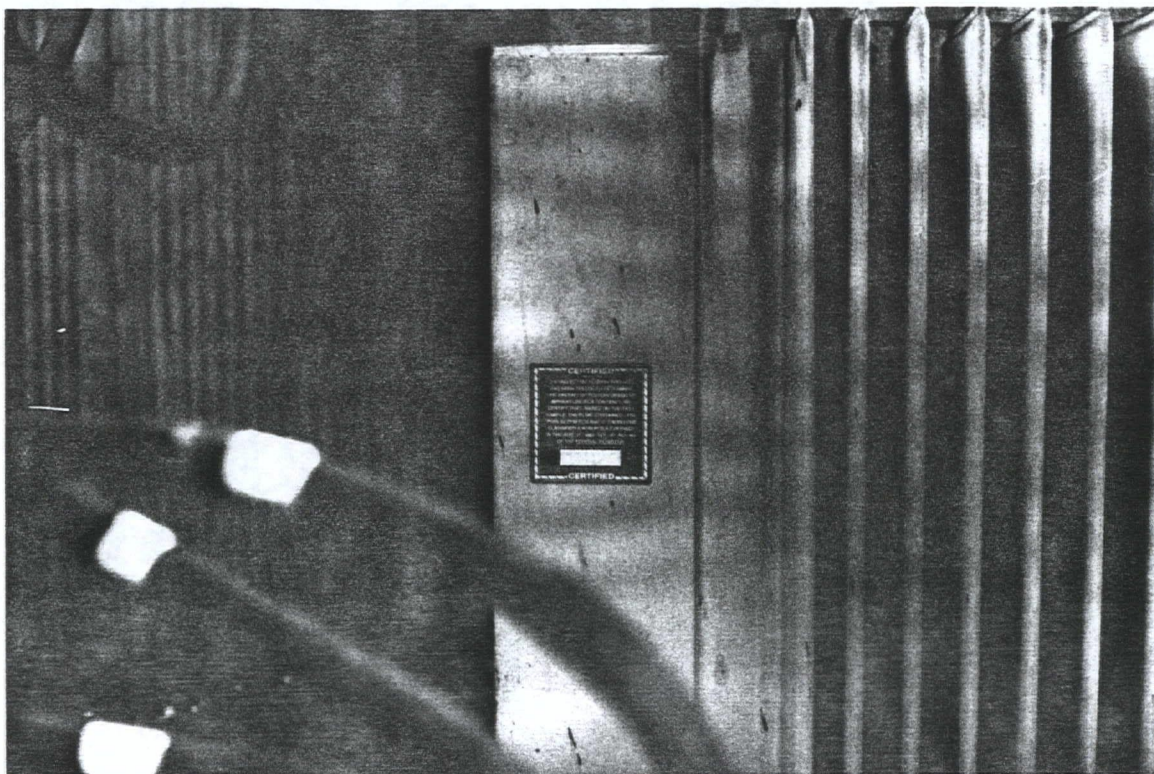
Status: The electrical transformer was closely inspected and a certification by Seattle City Light indicates that the oil contains less than 50PPM/PCB. Nevertheless, the area is fenced and secured from employee intervention. See photo number 10, below, indicating inspection decal.

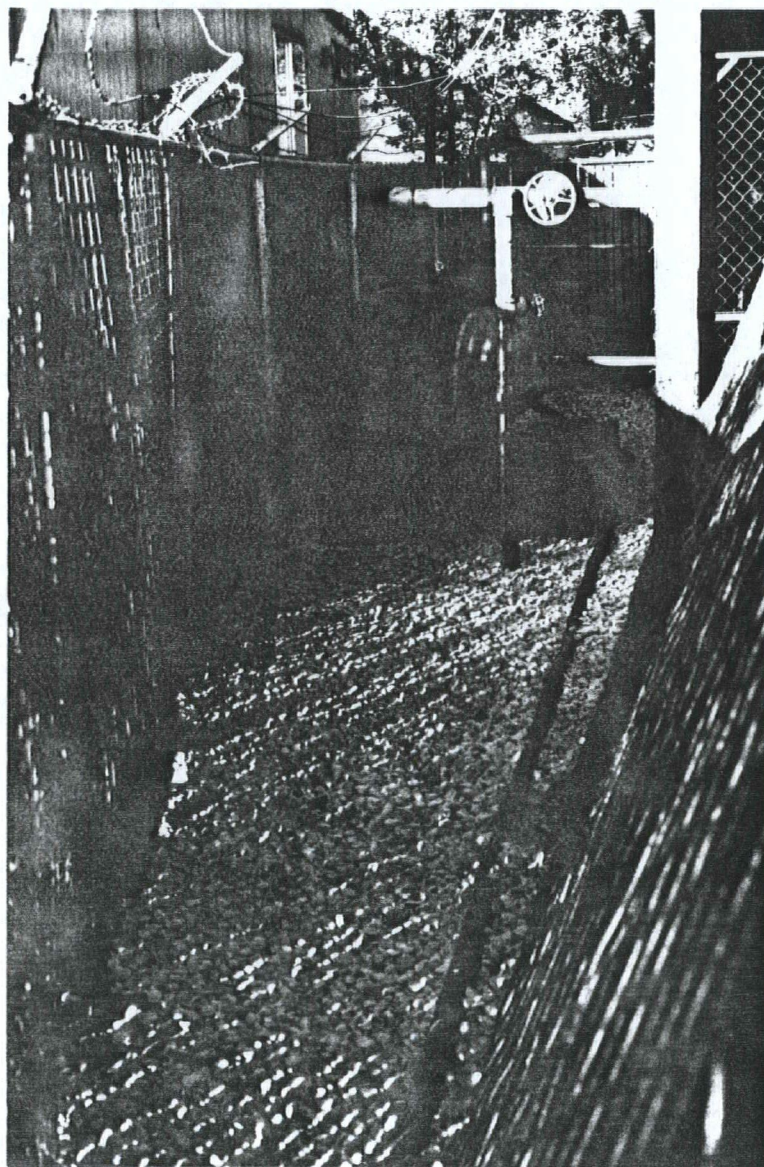
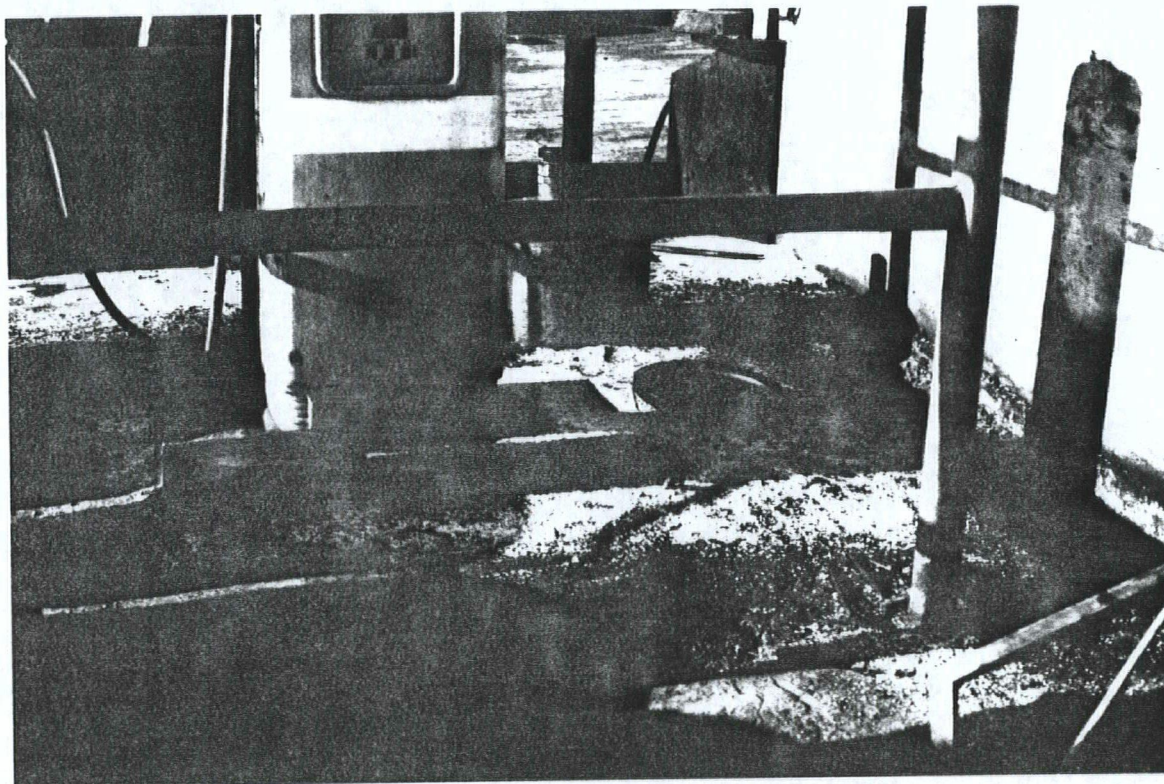
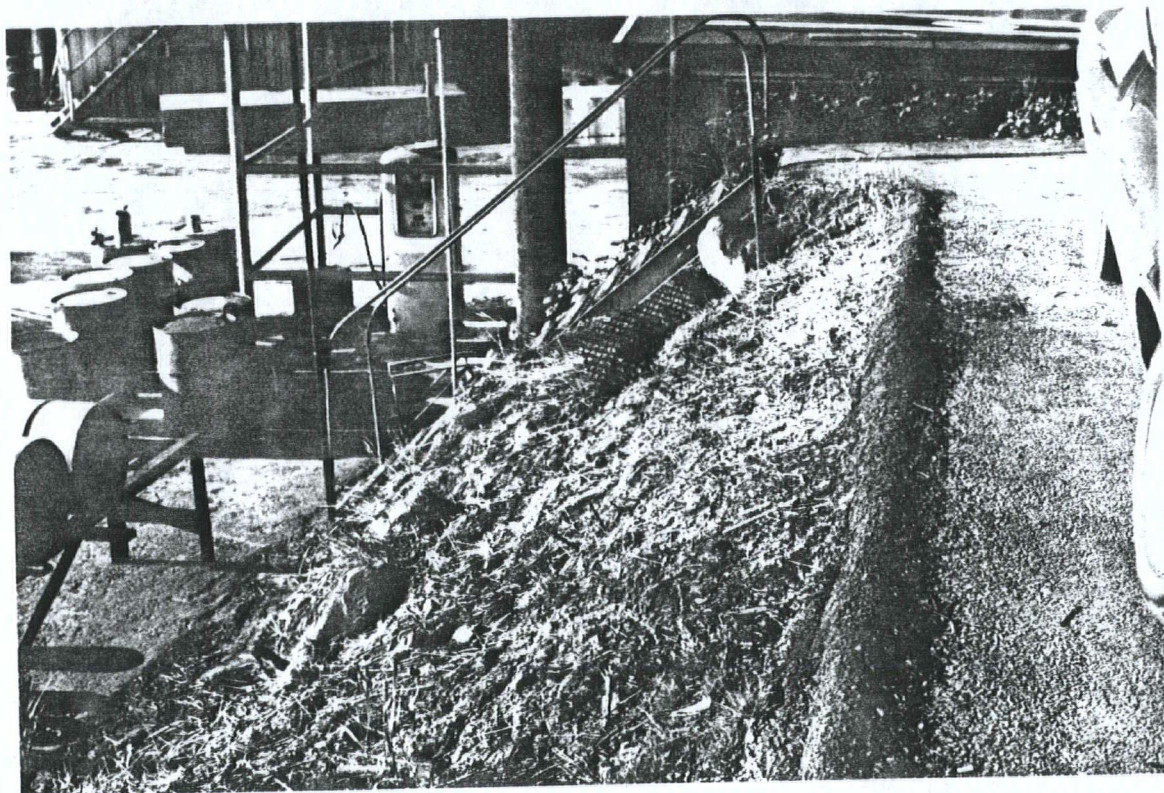
The areas around the air compressor tank, gasoline pump and the western bank are being cleaned as indicated in photos number 11 through 13. Additionally, retention walls are under construction around the gasoline pump as can be seen photo number 12. These photos follow on page ten and page eleven.
